Truck Loading

Lesson Learned #112
INGAA LLR Workshop
February 19, 2014

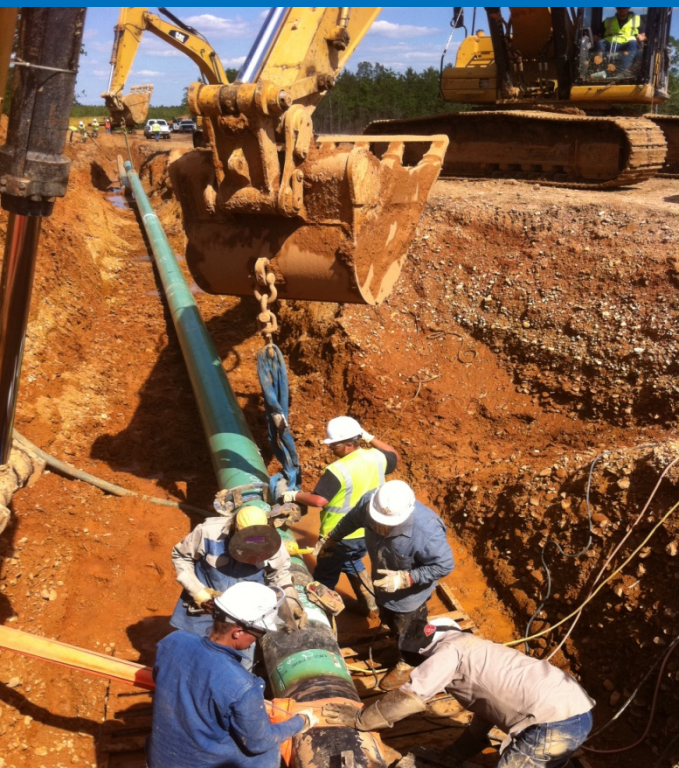
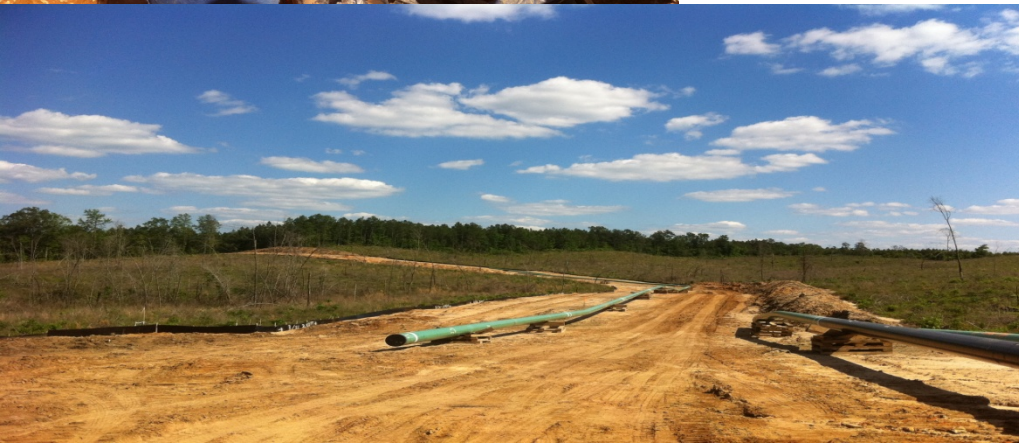
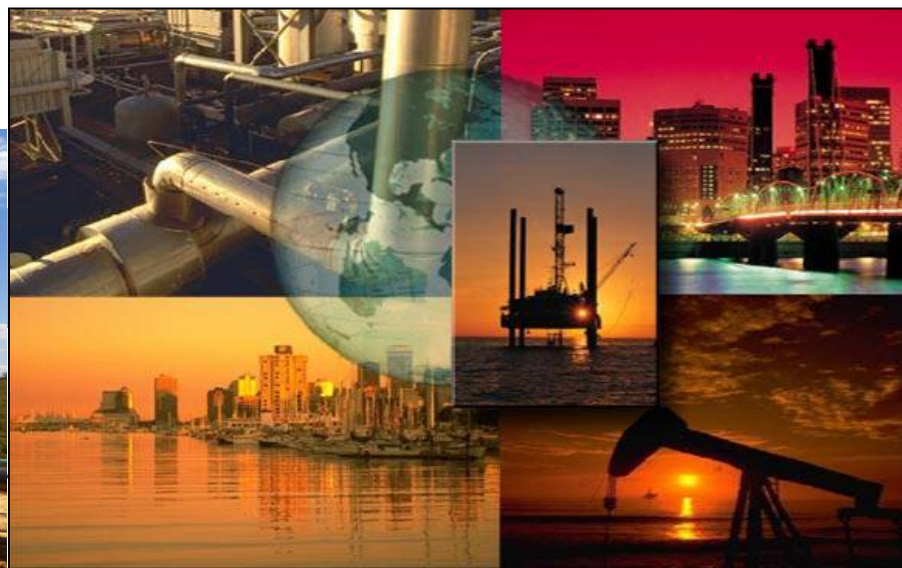
A contractor crew was loading a truck with piping for removal from the job site. A forklift was being used to load 20" pipe onto the truck which already had 16 joints of 2" pipe on it. Skids were placed on top of the 2" pipe joints in order to create a base for the larger 20" pipe joints.

The forks were tilted downward to allow the larger pipe to roll off and, upon doing so, the pipe gained enough momentum to roll to the opposite side of the truck. The skids that were placed on top of the 2" pipes tilted downward allowing the 20" to continue to roll and make contact with the bed stakes. The bed stakes did not stop the pipe from rolling off the truck and onto the ground. No one was in the area where the pipe fell because the crew discussed this type of hazard prior to beginning the task and documented the hazards along with the mitigation steps on their JSA.
